#### ETHICO N, INC.

August 10, 1990

TEN YEAR *IN VIVO* SUTURE STUDY SCANNING ELECTRON MICROSCOPY FIVE YEAR REPORT

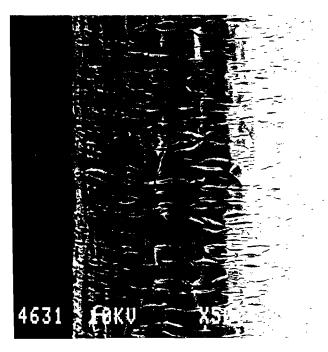
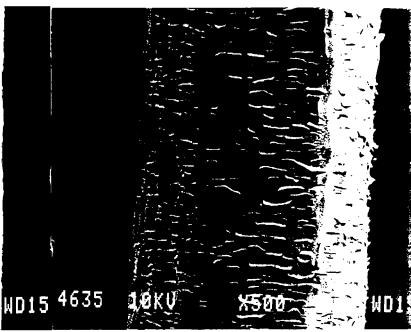
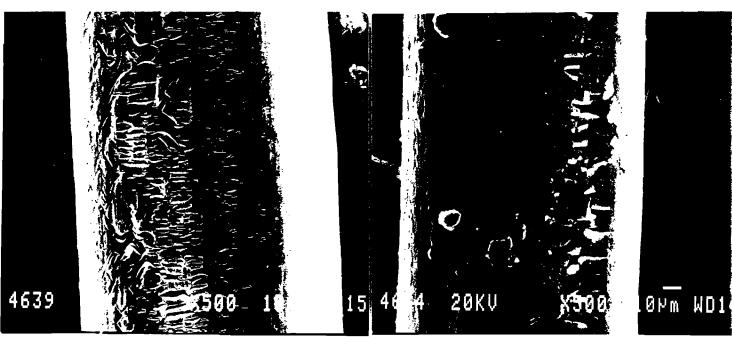
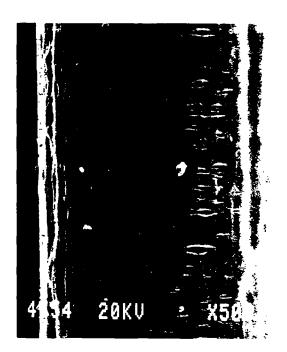
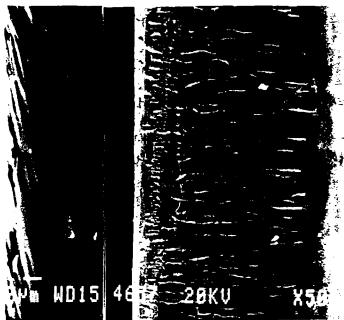
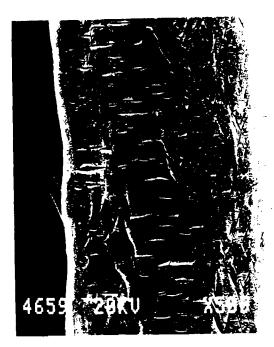
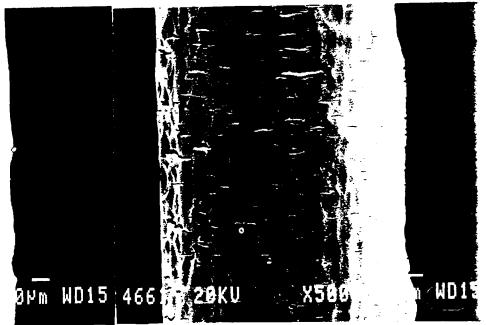
### Ethilon Explants

SEM of ETHILON Explants: Figure 1, 2

Suture explants from all five dogs from all sites showed cracking and abrasions in at least 30% of the total suture surface. The abrasions were deep enough to loosen the dyed surface layer of several microns. The cracking shown was found in the undyed underlying layer.

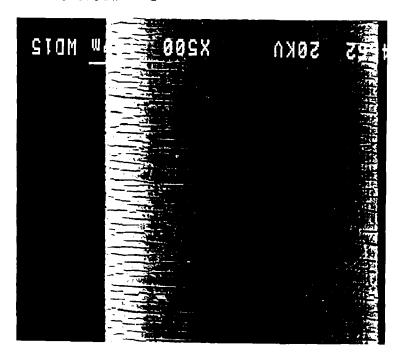
Prolene Explants

SEM of PROLENE Explants: Figure 5, 6

Explanted sutures from dogs 1994, 2000 and 2006 did not show any cracking or abrasions. On explants from dogs 2012 and 2018 a few cracked areas were observed; both of these sutures came from site 4.
